NPDES Compliance Inspection Report

Owyhee Meat Company, Inc. Homedale, Idaho

Inspection Date: May 13, 2021

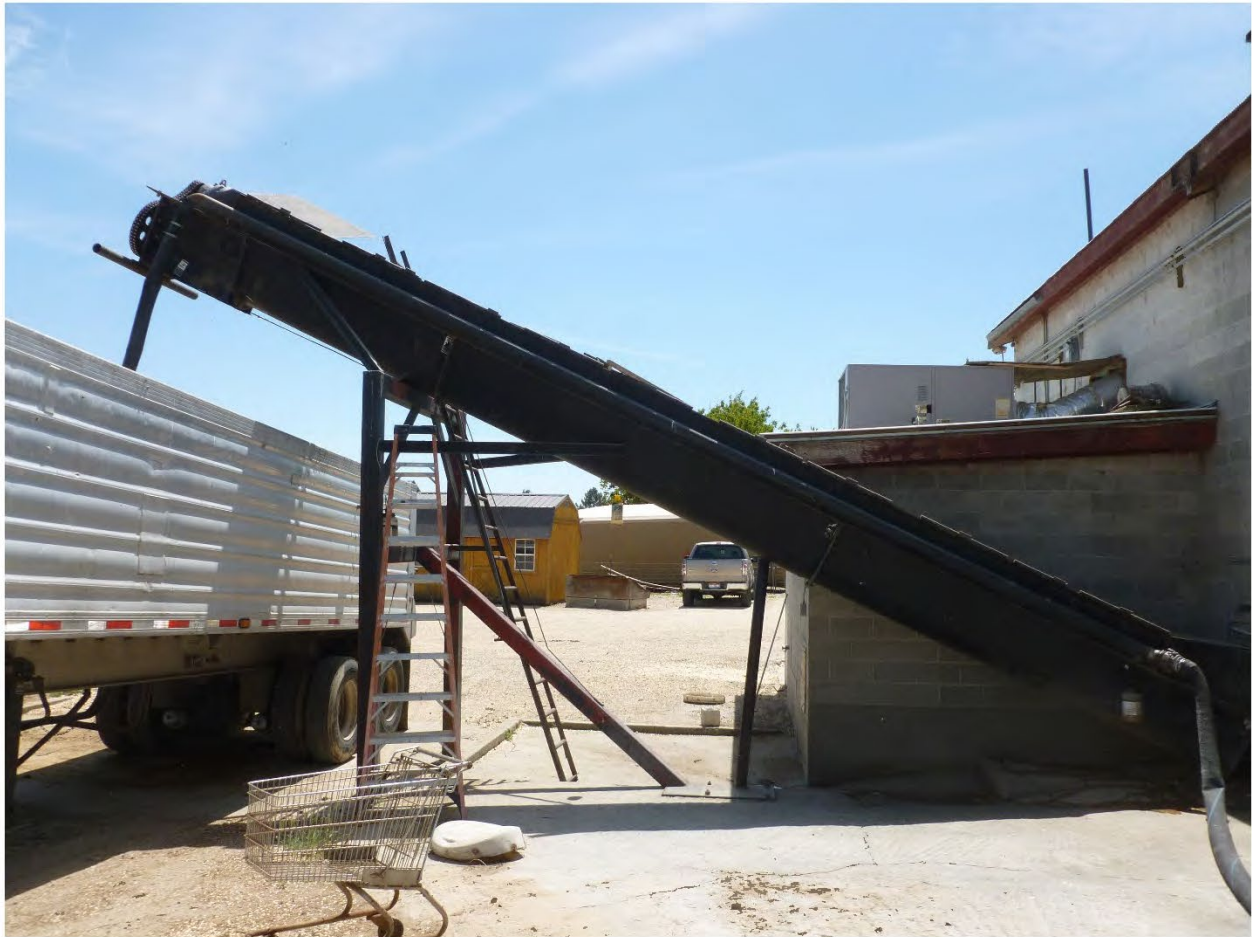
I did verify that the facility had installed a wastewater treatment system that treated the process wastewater generated on the site. The offal produced through the slaughter and processing of the cattle is put on conveyor and loaded onto a truck for disposal (**Photo 1**). The animals’ blood is collected in a “blood pit” (**Photo 2**). The contents of the “blood pit” are pumped into a tank on the

Photo 1 / P1000900 – Waste Conveyor

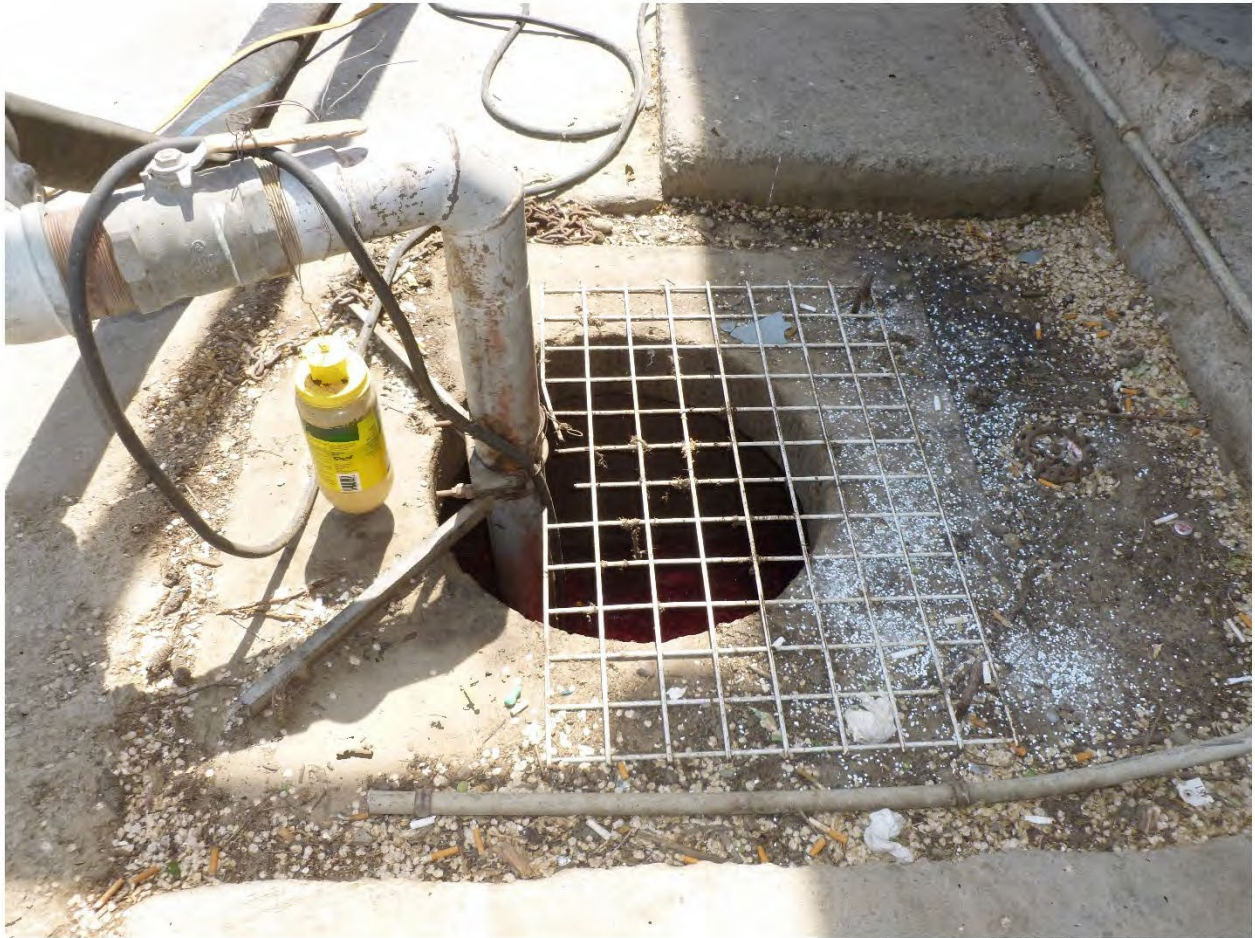
Photo 2 / P1000901 – Blood Pit

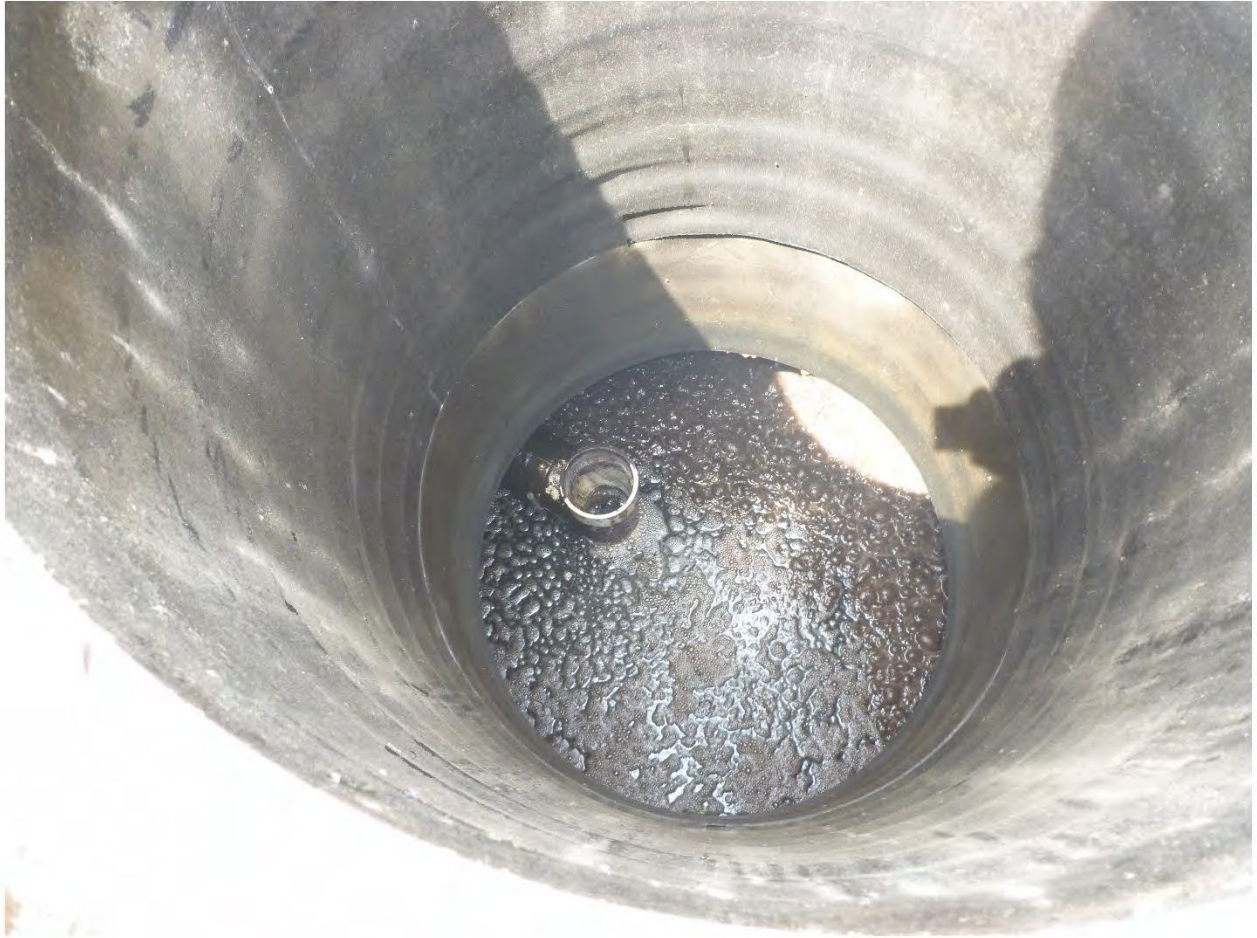
waste truck carrying the offal. All other process wastewater is pumped into several tanks that connect in series. The waste goes through aeration (**Photo 3**) followed by two identical filtration systems (**Photo 4**). Once the wastewater has gone through the last treatment tank, it is sent to a pressurized drainfield measuring 120ft².

Photo 3 / P1000902 – Aerator

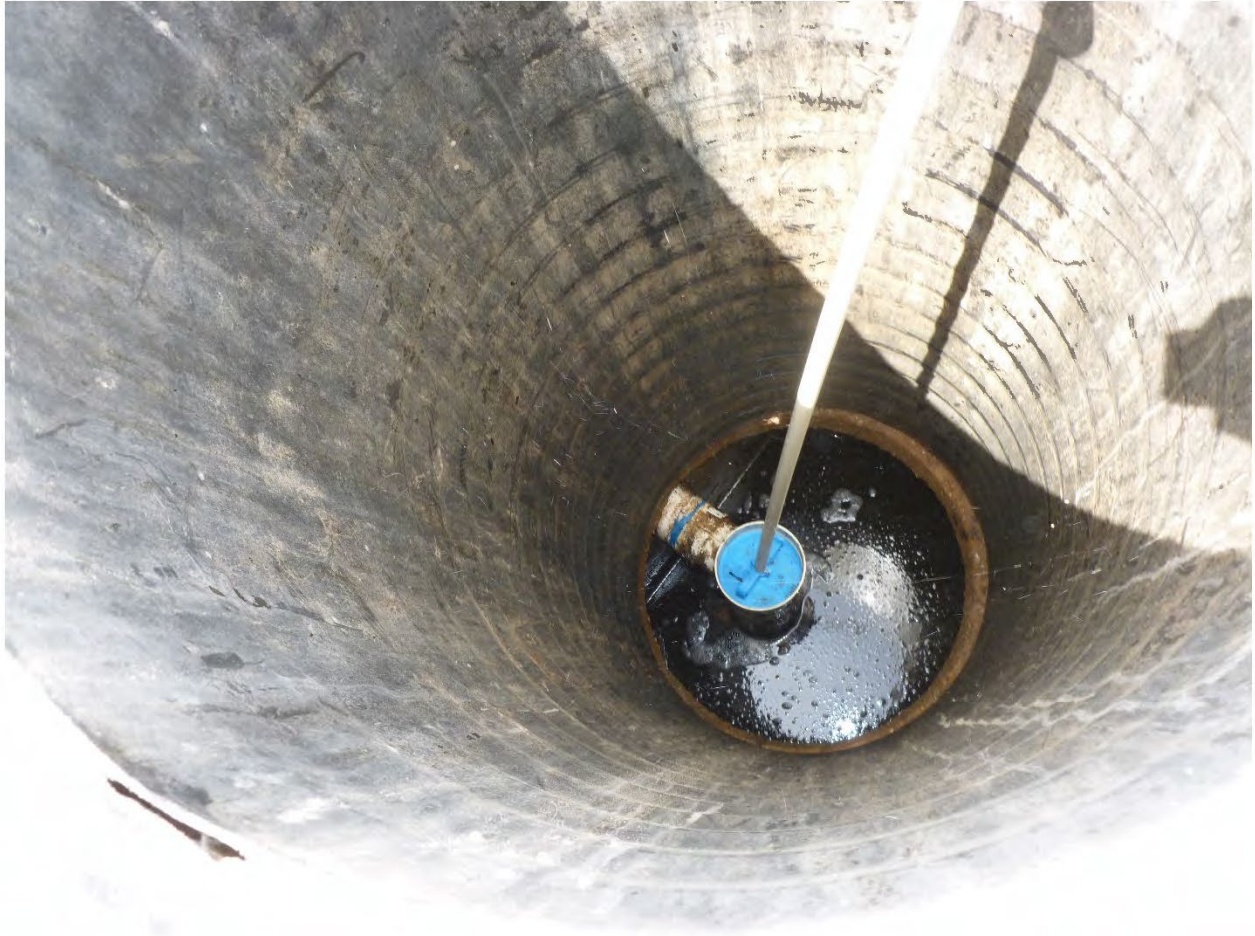
Photo 4 / P1000904 – Filter
